**NATIONAL TRANSPORTATION SAFETY BOARD
Office of Aviation Safety
Washington, D.C. 20594**

Structures Group Chairperson's Factual Report of Investigation

MIA99FA245

Aircraft : Beechcraft B90 King Air, N338AS
Operated by CP Horizons, Inc.

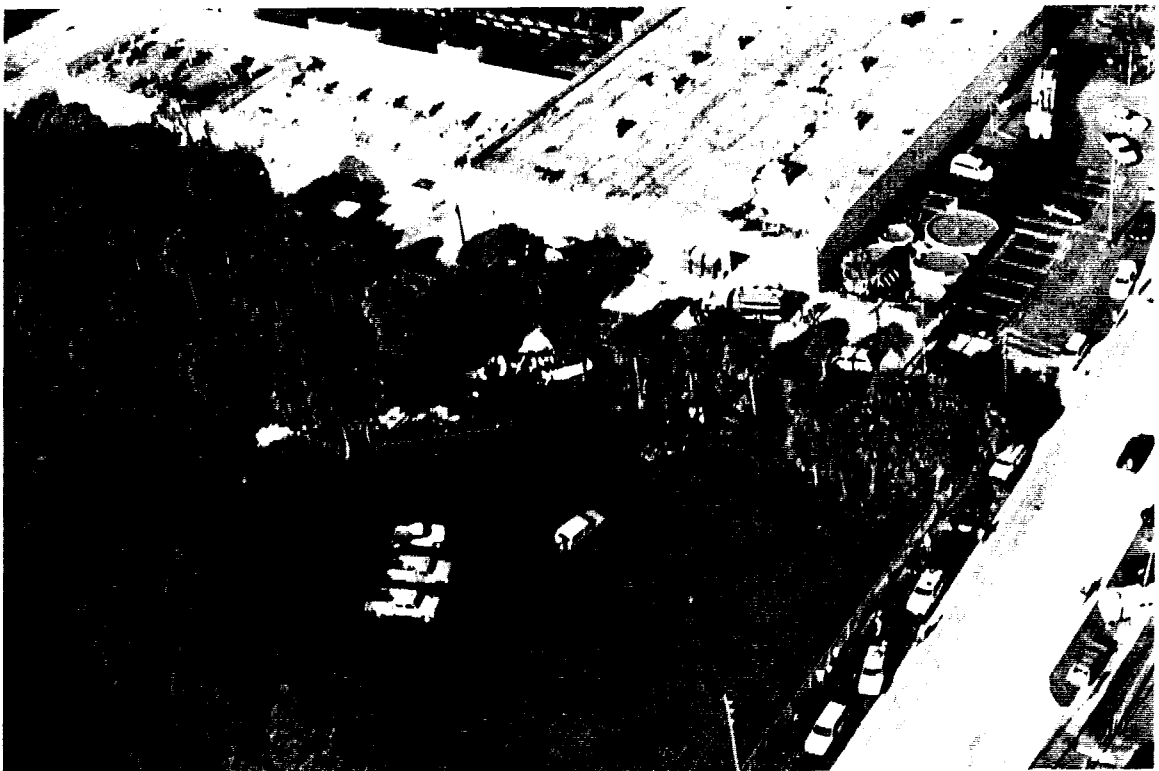
Photo #2. Aerial View of the Pool Warehouse and the Wreckage Site. The arrow points to the location of where the King Air B90 first contacted the building.

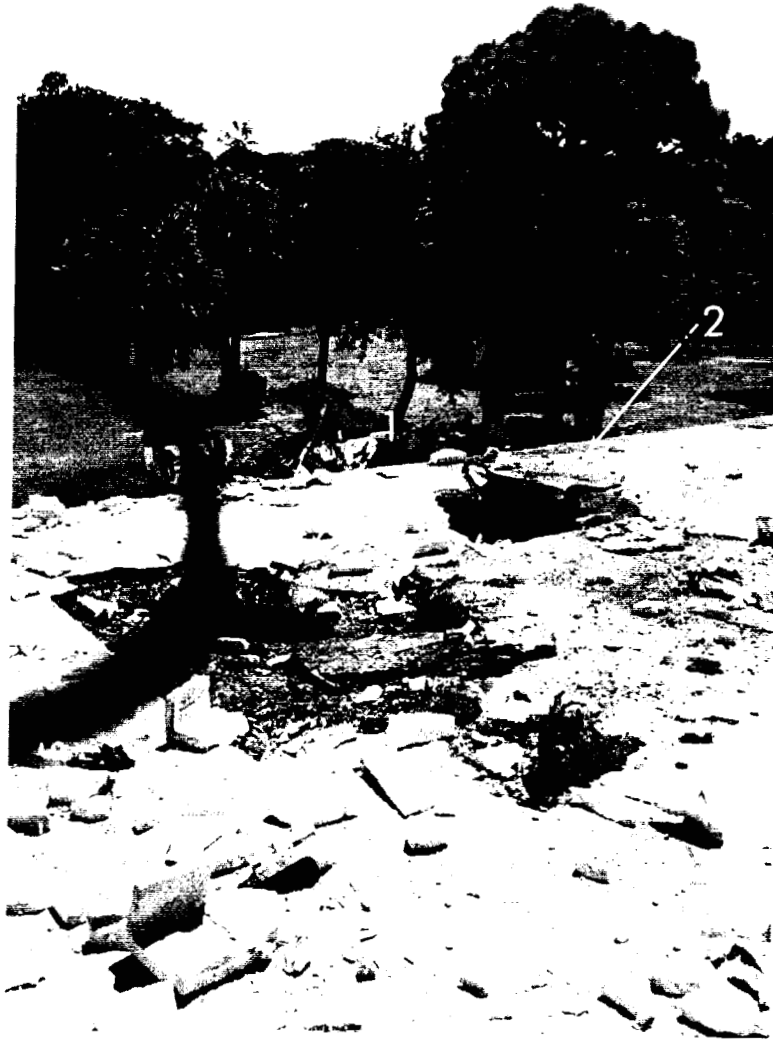
The right main landing gear wheel assembly and piston were found in a pool warehouse, approximately 100 feet away from the wreckage site. The left main tire and fractured pieces of the wheel's rim were found north of the pool warehouse, approximately 200 feet away. The nose gear was found before the fence line, next to a dumpster approximately 25 feet from the main wreckage. A few personal effects were found prior to the main wreckage site. There was evidence of black rubber markings on the top corner of the pool warehouse. There were two depressions created by the airplane in the pool warehouse's roof, with one depression penetrating through the surface.

Photo #3. View of the roof of the Pool Warehouse. The arrows point to where the King Air B90 contacted the building. Arrow #1 points to where the fuselage contacted the building. Arrow #2 points to where the right hand main landing gear punched through the building.

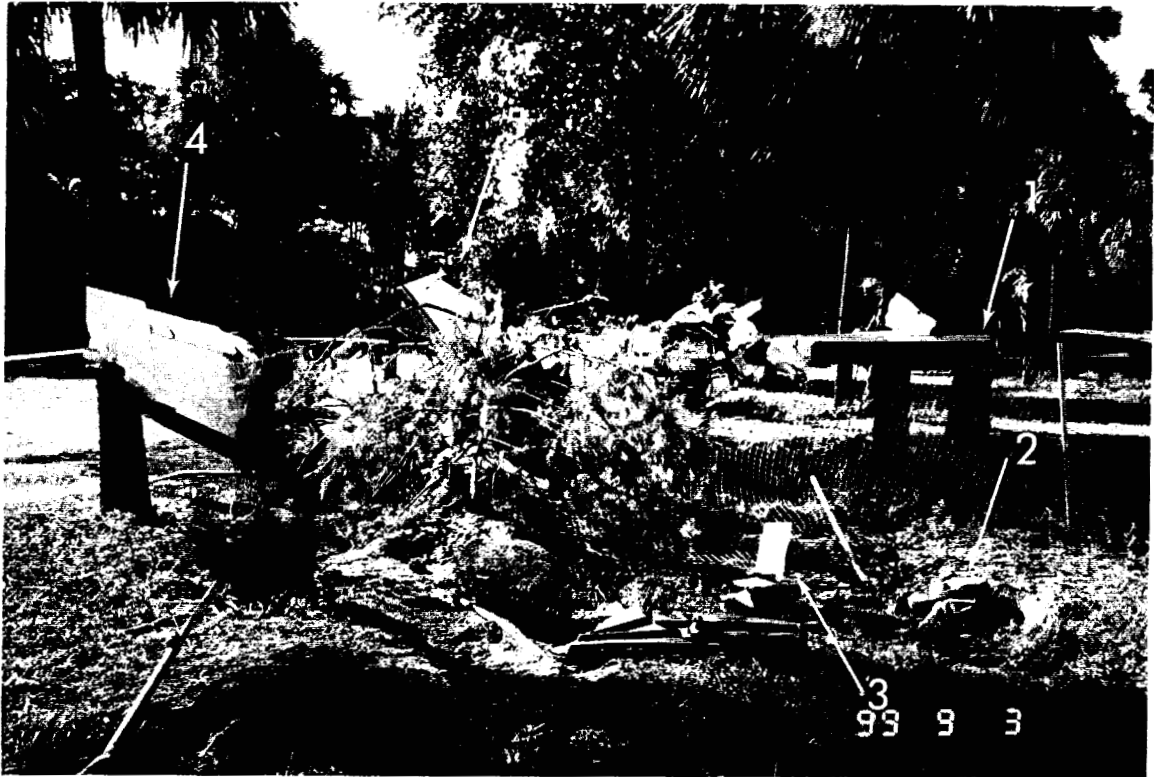
Photo #4. View of the Wreckage Site. Arrow #1 points to the right wing. Arrow #2 points to the nose landing gear. Arrow #3 points to the left inboard flap. Arrow #4 points to the left wing. Arrow #5 points to the vertical fin.

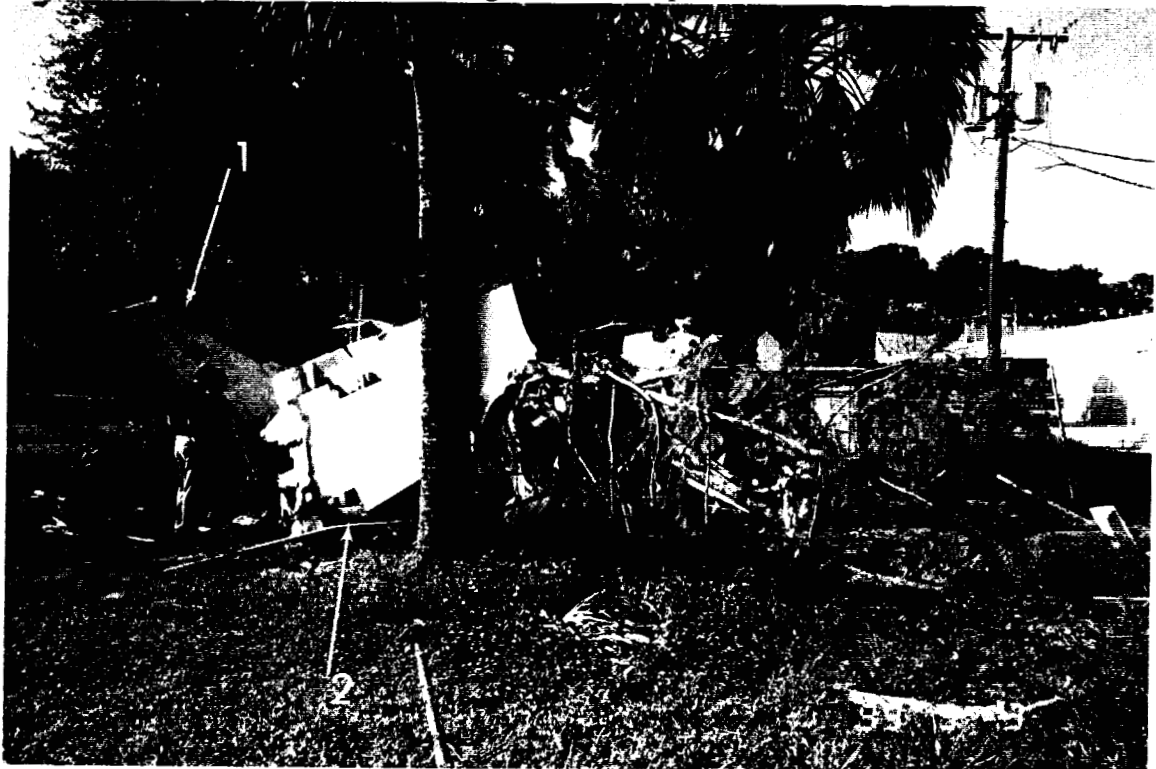
Approximately 37 inches from the wing tip and moving 42 inches inboard, the left wing's main spar up to the leading edge had crushing damage. There was a prop strike mark through the outboard edge of the wing tank cover, approximately 122 inches from the wing tip, and penetrating through the entire wing structure. There was compression damage and buckling on the upper skin continuing to the trim tab point. The trailing edge exhibited minor impact damage.

The right hand side of the vertical fin attachment to the empennage had fire damage consisting of bubbles in the paint. The vertical fin and rudder had minor paint discoloration.

Photo #5. View of Wreckage Site. Arrow #1 points to the paint discoloration on the right hand side of the vertical fin and rudder. Arrow #2 points to the prop strike through the left wing.

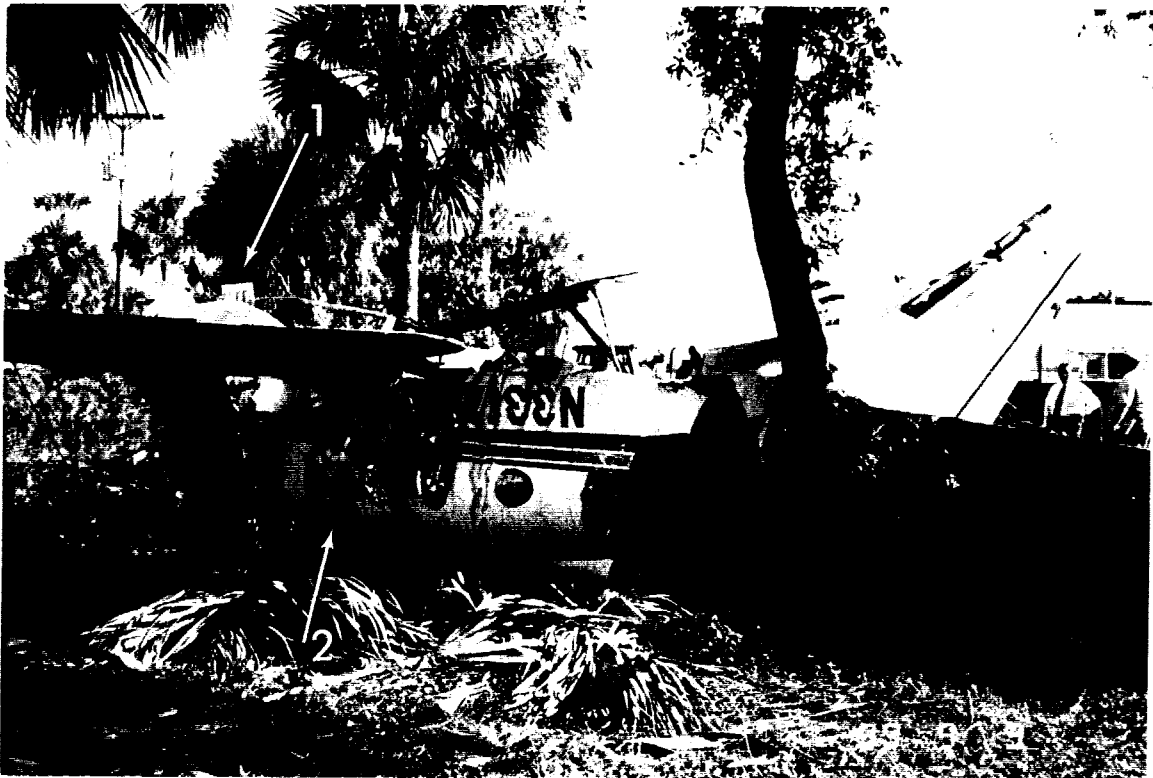
The right hand side of the fuselage had extensive fire damage; sooting, bare metal, and paint discoloration, starting at FS 166.90 and continuing from the window down and moving aft to FS 216.00. The right wing was still attached. The emergency exit hatch was still in place and the locking mechanism was engaged. For passenger removal the rescue team cut through the right FS 266.25 and continued horizontally to FS 166.9.

The right main gear was found in a pool warehouse with the piston, wheel, brake and tire assembly still intact. The right main landing gear doors were open and the remaining right main landing gear cylinder was protruding and pushed aft.

Photo #6. View of the wreckage site. Arrow #1 points to the right main landing gear doors. Arrow #2 points to the emergency escape hatch.

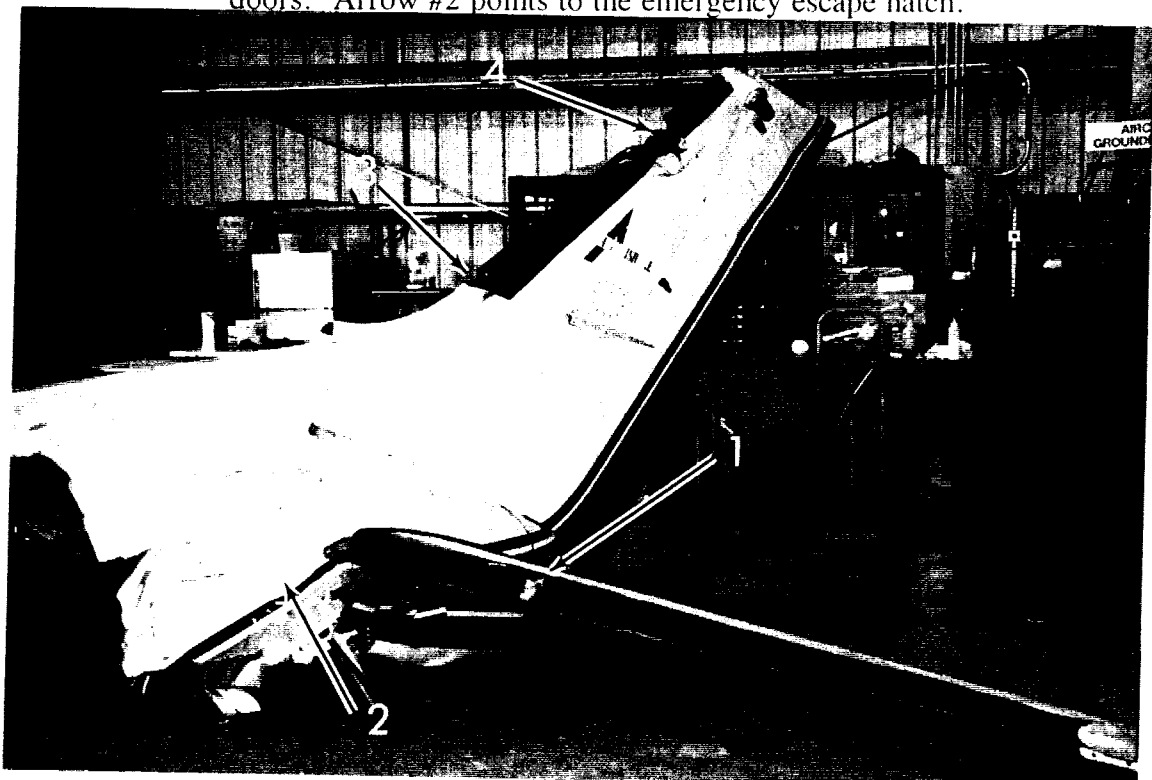
The empennage was separated from the fuselage at the aft pressure bulkhead but still had the flight control cables attached. The left hand side of the empennage had tree impact damage, approximately 21 inches in diameter, with tree scrape marks and black scrape marks transversing vertically. The lower skin was missing from the fracture to the bulkhead. The tail light assembly was partially separated from the vertical fin. The rudder and trim control surfaces were still attached and intact.

The leading edge of the vertical fin had tree impact damage 16 inches from the top, which was 10 inches long and 8 inches deep. Brown scrape marks were in the same location. There was additional tree impact damage 57 inches from the top of the vertical fin with brown scrape marks and tree particles embedded in the damage.

The left stabilator had a tree impact damage, 14 inches in diameter, on the leading edge 16 inches outboard. There were tree particles in the damage. Approximately 1 foot of the forward section of the left stabilator was separated from the empennage. There was minor impact damage on the outboard leading edge. The outboard tip was crushed down.

Photo #7. The Left Side of the Empennage. Arrow #1 points to the tree impact damage on the leading edge of the stabilator. Arrow #2 points to the tree impact damage on the empennage. Arrow #3 points to tree impact damage on the leading edge of the vertical fin. Arrow #4 points to tree impact damage on the leading edge of the vertical fin.

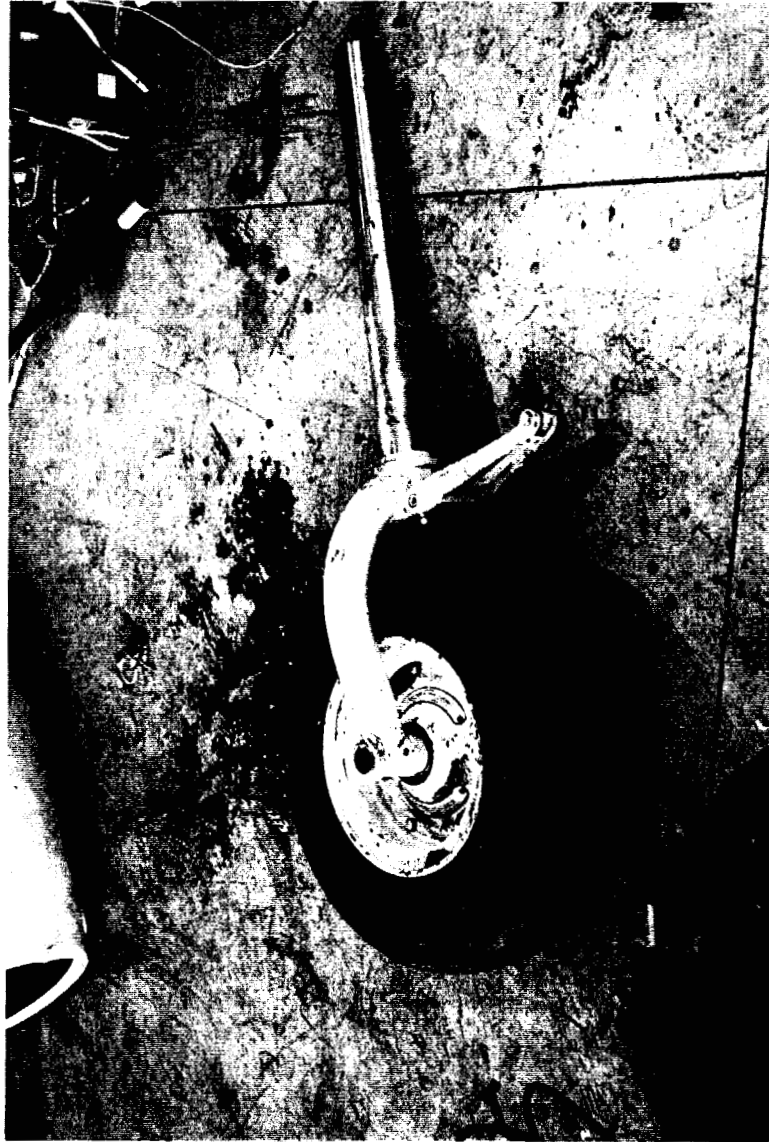
Photo #9. Nose Landing Gear.

The nose landing gear had dirt and scrapings on piston. The tire and wheel were intact, with the lower drag brace still attached. The drag brace assembly was broken at the upper drag brace lug.

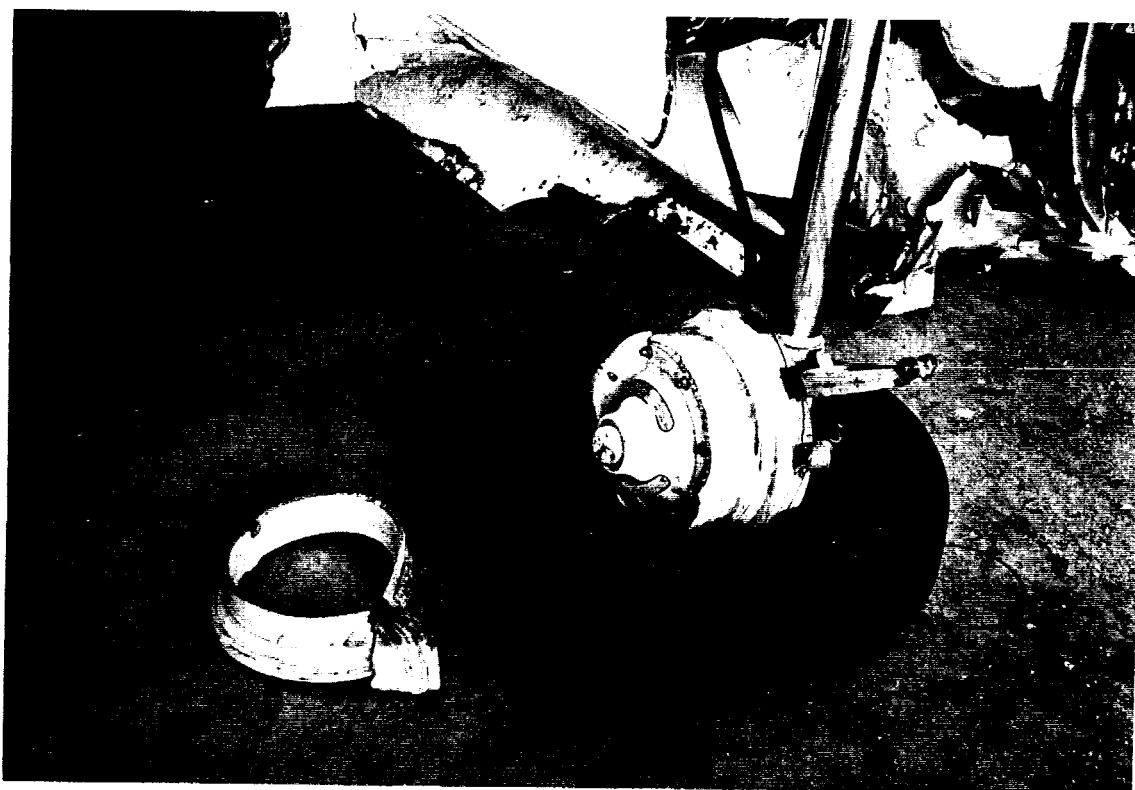
Photo #11. Left Main Landing Gear.

The left main landing gear's outboard attachment to the main spar was intact with minor damage to the outer flange. There was ash colored fire damage in this area. The left main landing gear's inboard attachment fitting was detached from the main spar at the bearing but the bearing was still attached to the gear.

The left main landing gear's main spar web was deformed forward. The main spar upper cap from the bathtub inboard bolt was bent up and forward 10 inches inboard. From 10 inches inboard the upper cap was bent aft. There was a fracture at bolt hole (10 inches). There was crushing in the web.

The down locking arm was broke. The actuator was extended 8 ½ inches from center of the nut. The fire damage was all the way to bare metal.

The left main landing gear outer wheel rim was fractured into two pieces and found North of the pool warehouse. The tire was also found North of the pool warehouse. The piston, partial wheel and brake assembly were found together as a group. The lower drag brace was attached but broken at the upper drag brace lug.
